Design changes notification for Maqueen

Involved Products	Micro: Maqueen Lite / Maqueen Plus V2
SKUs	ROB0148-CN, ROB0148-EN, ROB0148-KR, ROB0148-JP, ROB0148-TW, MBT0021-EN, MBT0021-EN-18650
Company	Zhiwei Robotics Corp.

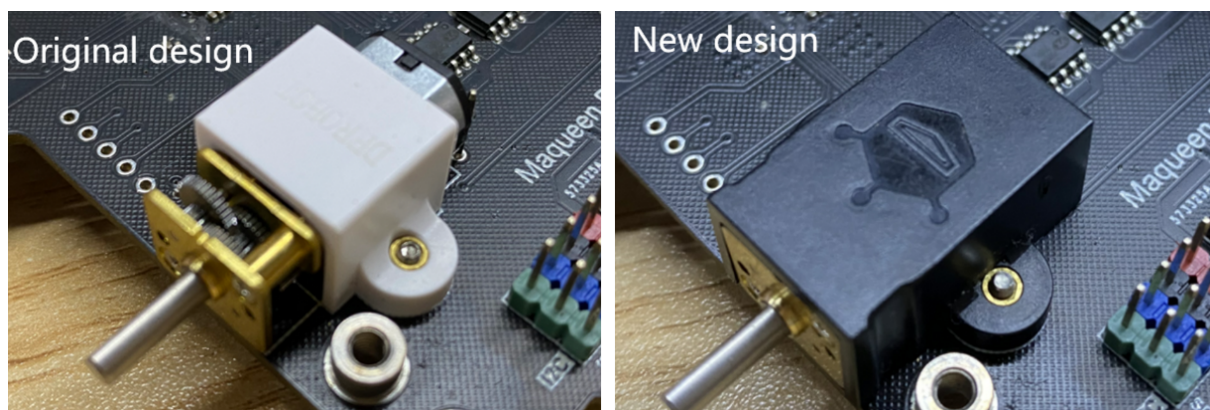
5. Image of the appearance changes of the N20 Motor fixing seat

- The original motor gear ratio of 1:150 is too high, which can lead to difficulties in controlling motor parameters and significant differences in motor performance. This can potentially cause the car to deviate from its intended path.
- The original Motor fixing seats not fully cover the motor gearbox, making it susceptible to the entry of hair and foreign objects into the motor gearbox.

- After the change, all shipped products will have a new black fixed seat, and the original white fixed seat has been discontinued.
- If there are any product after-sales processes, the old motor version should still be replaced with the old motor, while the new motor version should be replaced with the new motor. (If customers require a replacement with the new motor during the product after-sales process, please provide a remark or explanation.)
